Docket No. 217 – Development and Management Plan Inspection

Northeast Utilities Service Company Certificate of Environmental Compatibility and Public Need for the construction of a 345-kV electric transmission line and reconstruction of an existing 115-kV electric transmission line between Connecticut Light and Power Company's Plumtree Substation in Bethel, through the towns of Redding, Weston, and Wilton, and to the Norwalk Substation in Norwalk, Connecticut.

Date: May 25, 2006

Location: 345kV Underground Route

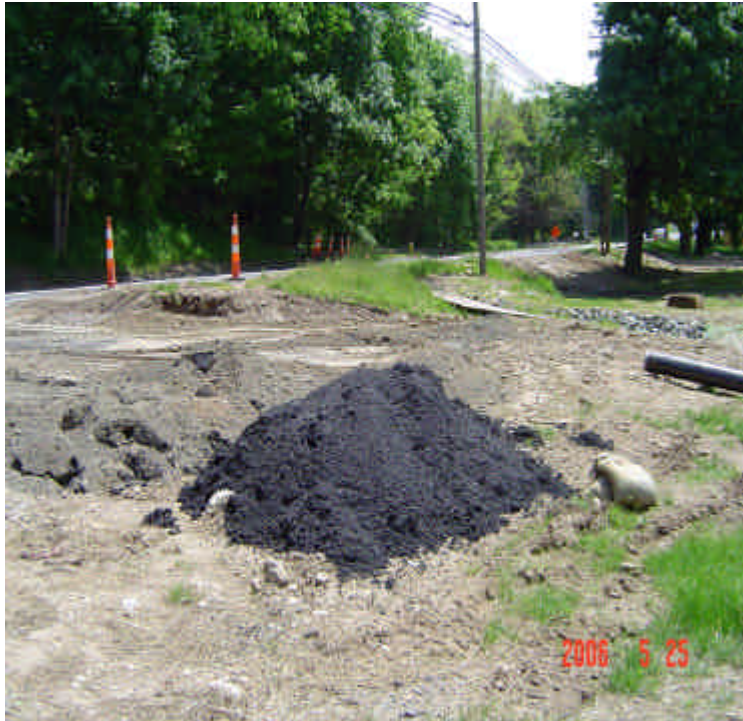
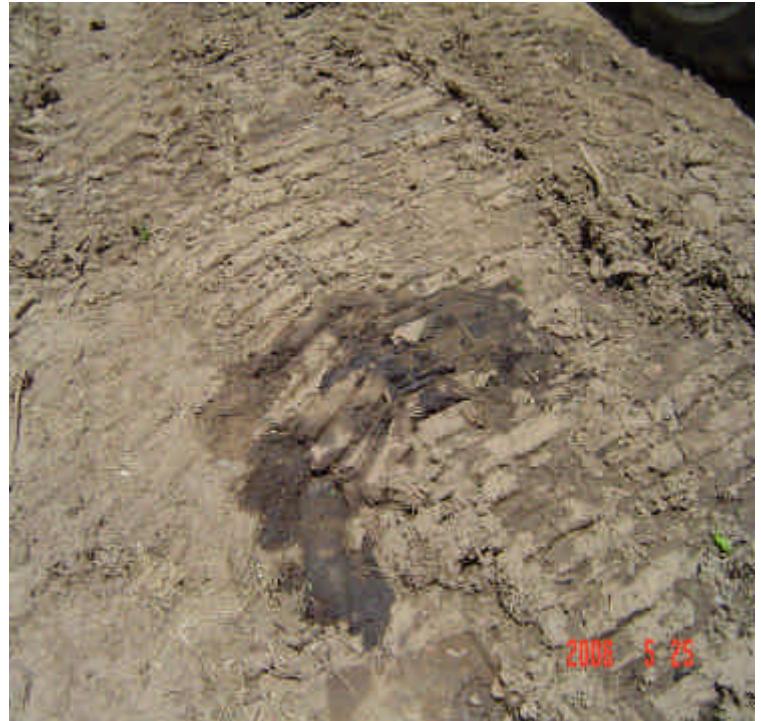
345kV (Norwalk Junction) Photo on the left shows where trenchwork was occurring at the access drive. Crews should pick up all asphalt piles and leftover materials. Photo on the right shows a small drip spot from a piece of equipment here that should be picked up if possible. 5/25/06

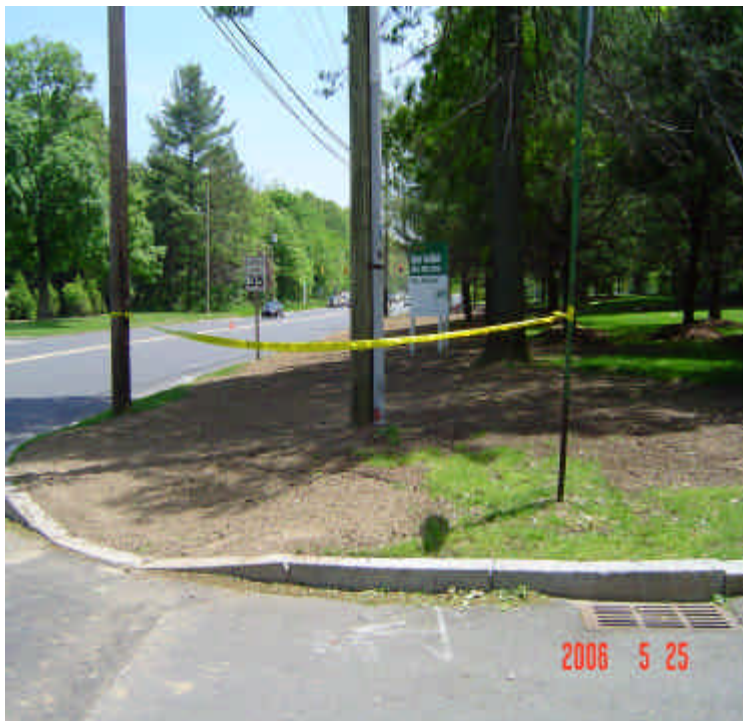
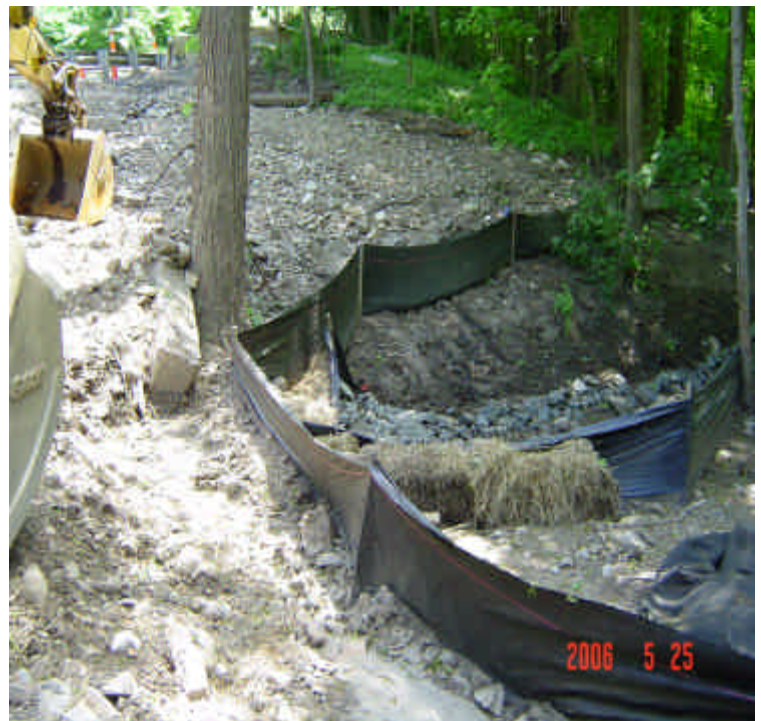
(Route 7): Photo on the left shows the Wilton Corp Park vault which was well graded. Photo on the right shows the backfilled trench near Old Danbury Rd. Additional silt fence was installed along the slope. 5/25/06

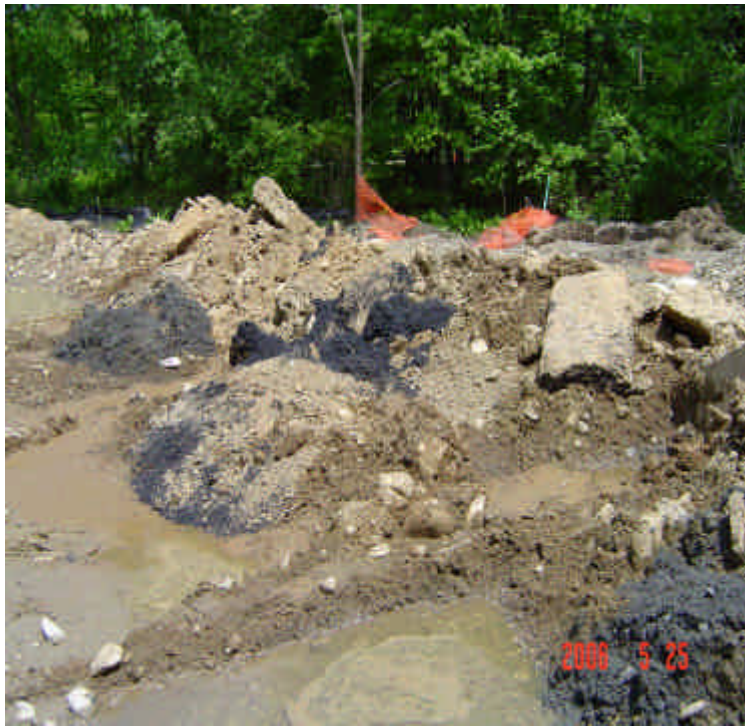
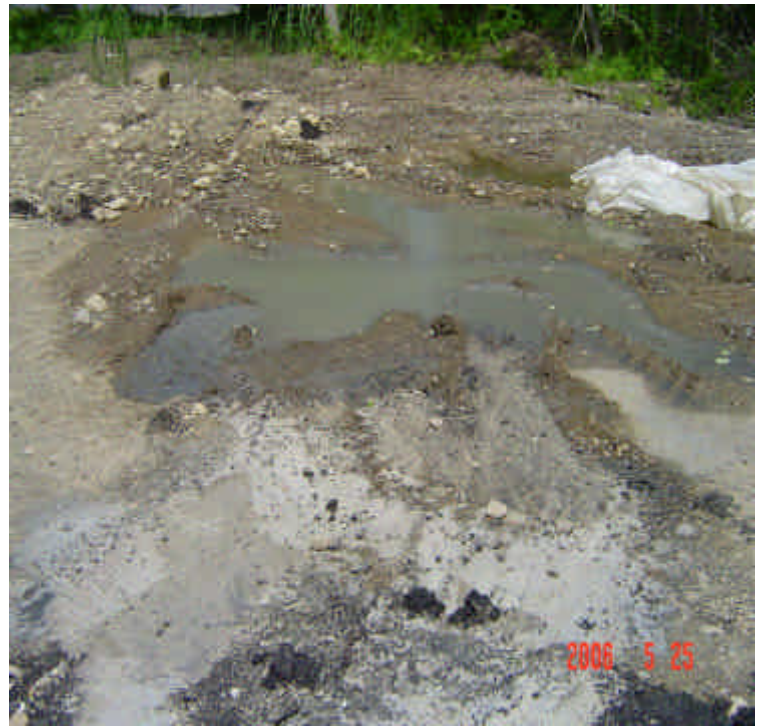
(HDD): Photo on the left shows asphalt debris and rubble piled at the HDD site. Continue to remove this daily and especially prior to restoration. Photo on the right shows one of several concrete washout spots noted here. Crews need to designate and contain this material. 5/25/06

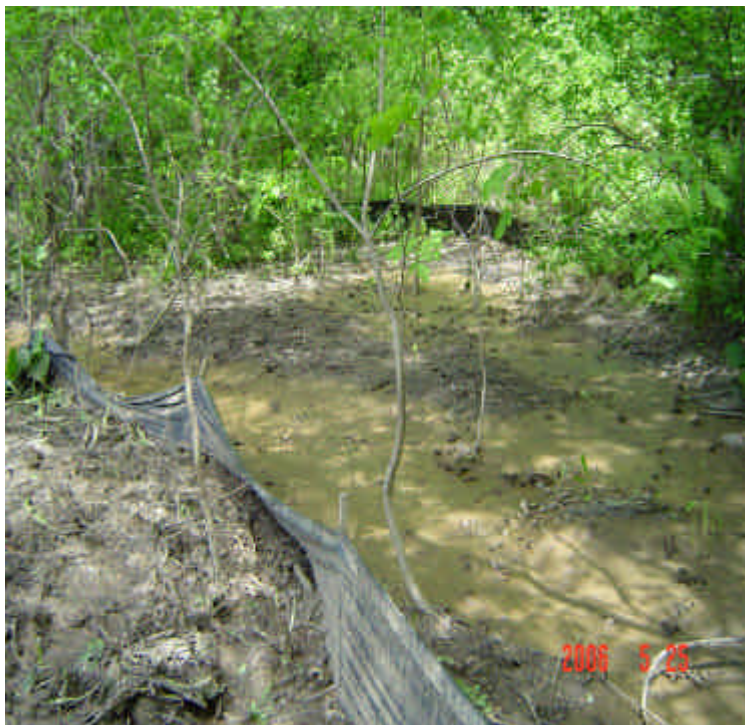
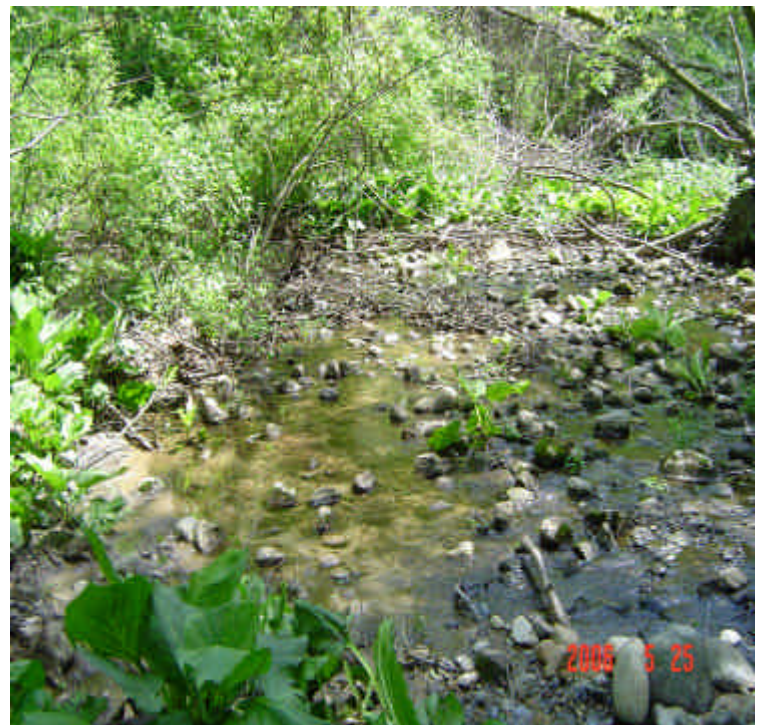
Photo on the left shows where built up sediment remains and appears to have worsened in the wetland along the east of the basin. Photo on the right shows the channels behind the basin where the downed silt fence and some of the built up sediment was removed. 5/25/06

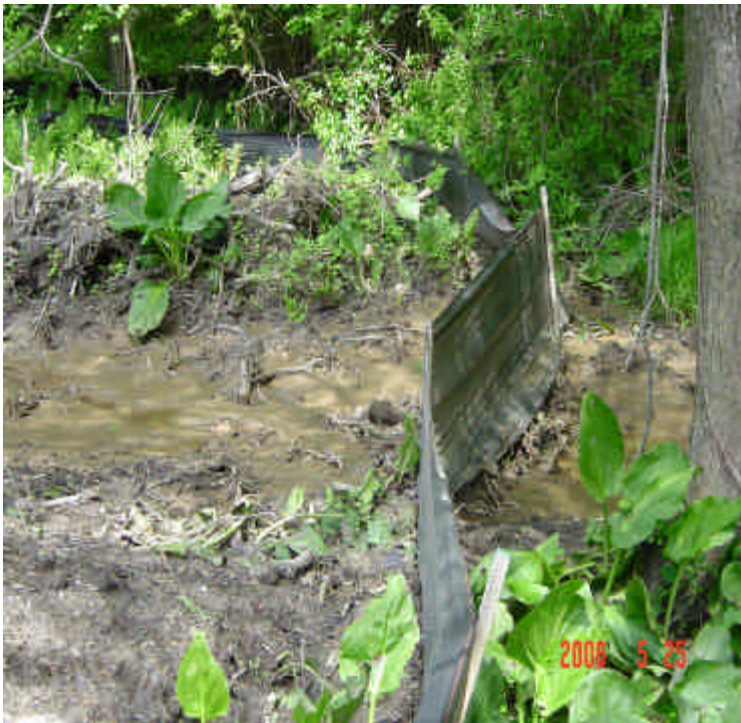
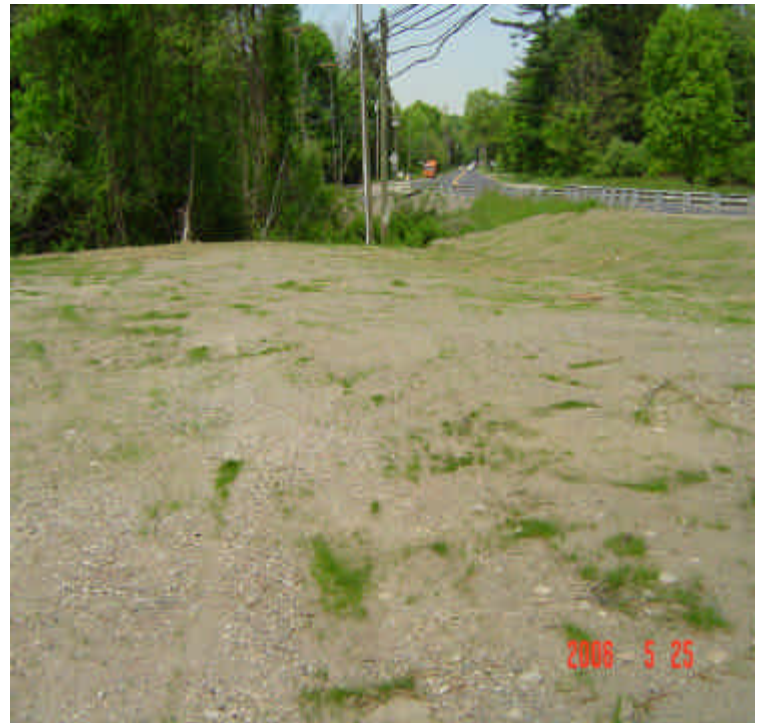
Photo on the left shows where sediment flowing into the eastern wetland is moving under the silt fence to the channels beyond the basin. Sediment will have to continue to be removed from both areas. (Wilton HS J&B): Photo on the right shows where grass growth remains sparse and the area likely needs to be reseeded and placed with more topsoil. 5/25/06

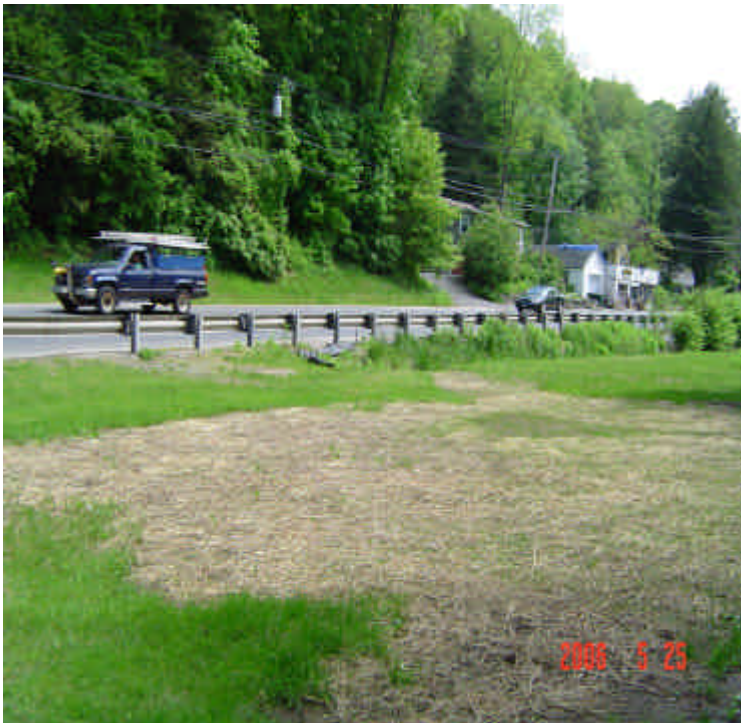
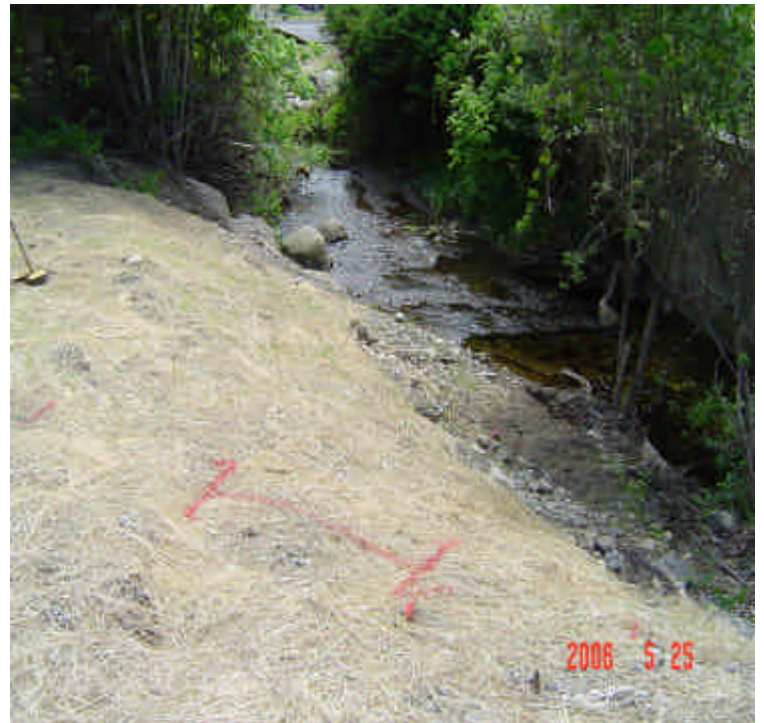
(Rt 7): Photo on the left shows where a portion of the storage area was mulched and restored. (Rt 107): Photo on the right shows where the slope at Georgetown Deli is waiting for some repair and new erosion control matting. 5/25/06

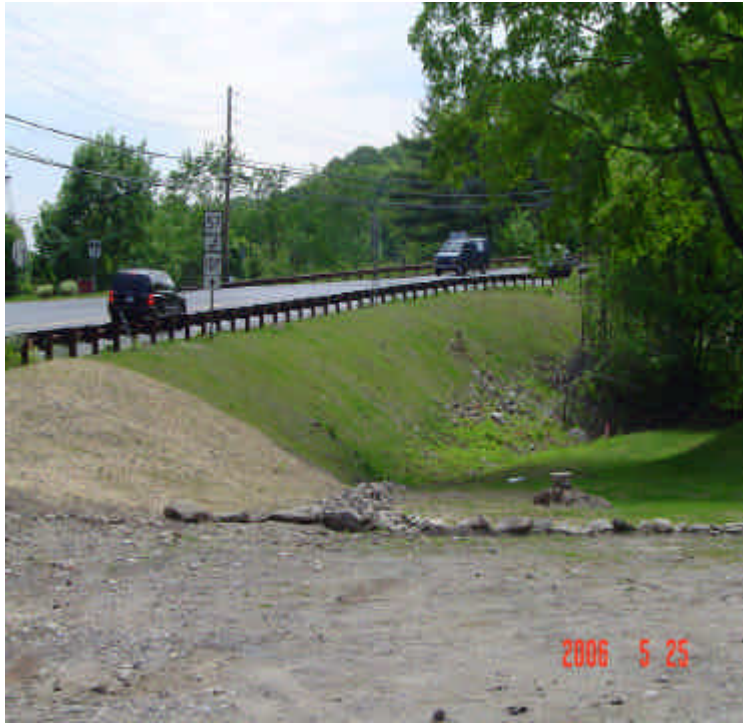
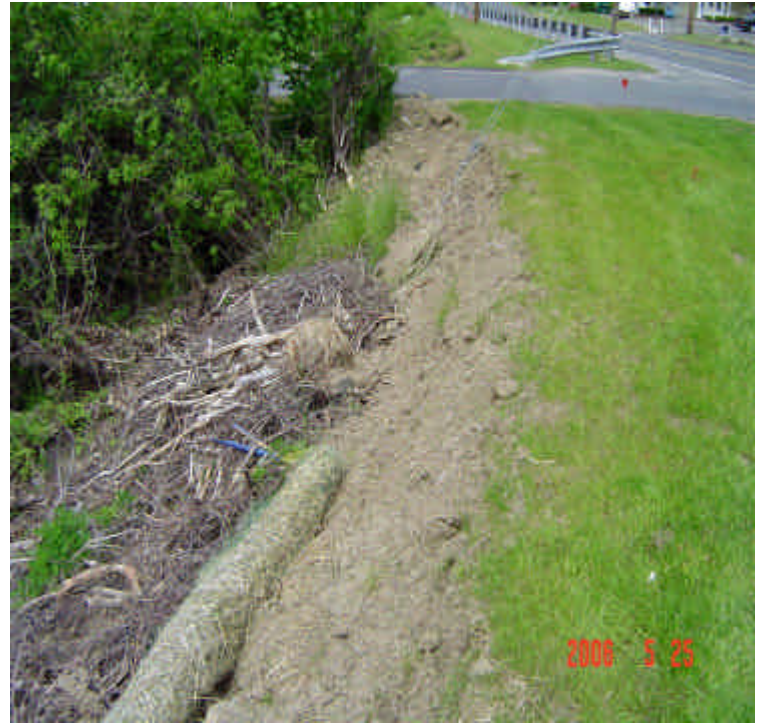
(Rt 107): Photo on the left shows the restored roadway slope south of Georgetown Deli above the river where grass is returning. Photo on the right shows the bank along the stream north of the Deli where the mat needs to be extended. 5/25/06

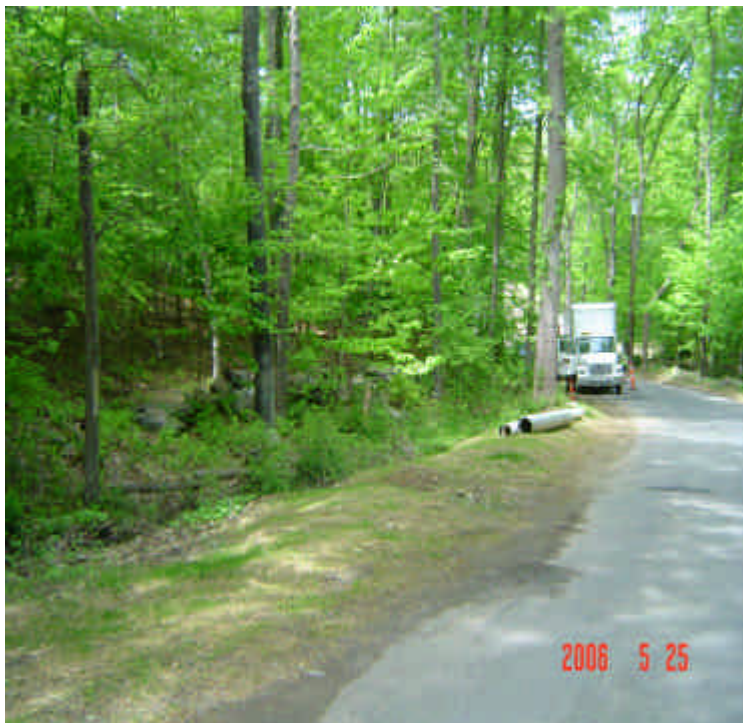
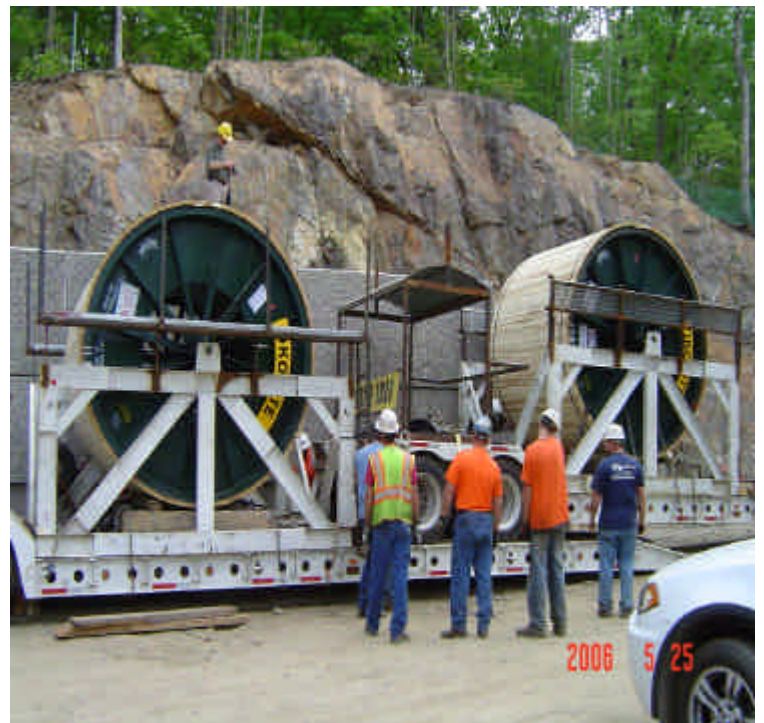
Photo on the left shows the roadside along Umpawaug Rd. with good grass growth. Crews are accessing the vaults here. Photo on the right shows spools being placed at Archers Lane to pull cable. 5/25/06
